Beware of non-regular valley gutters

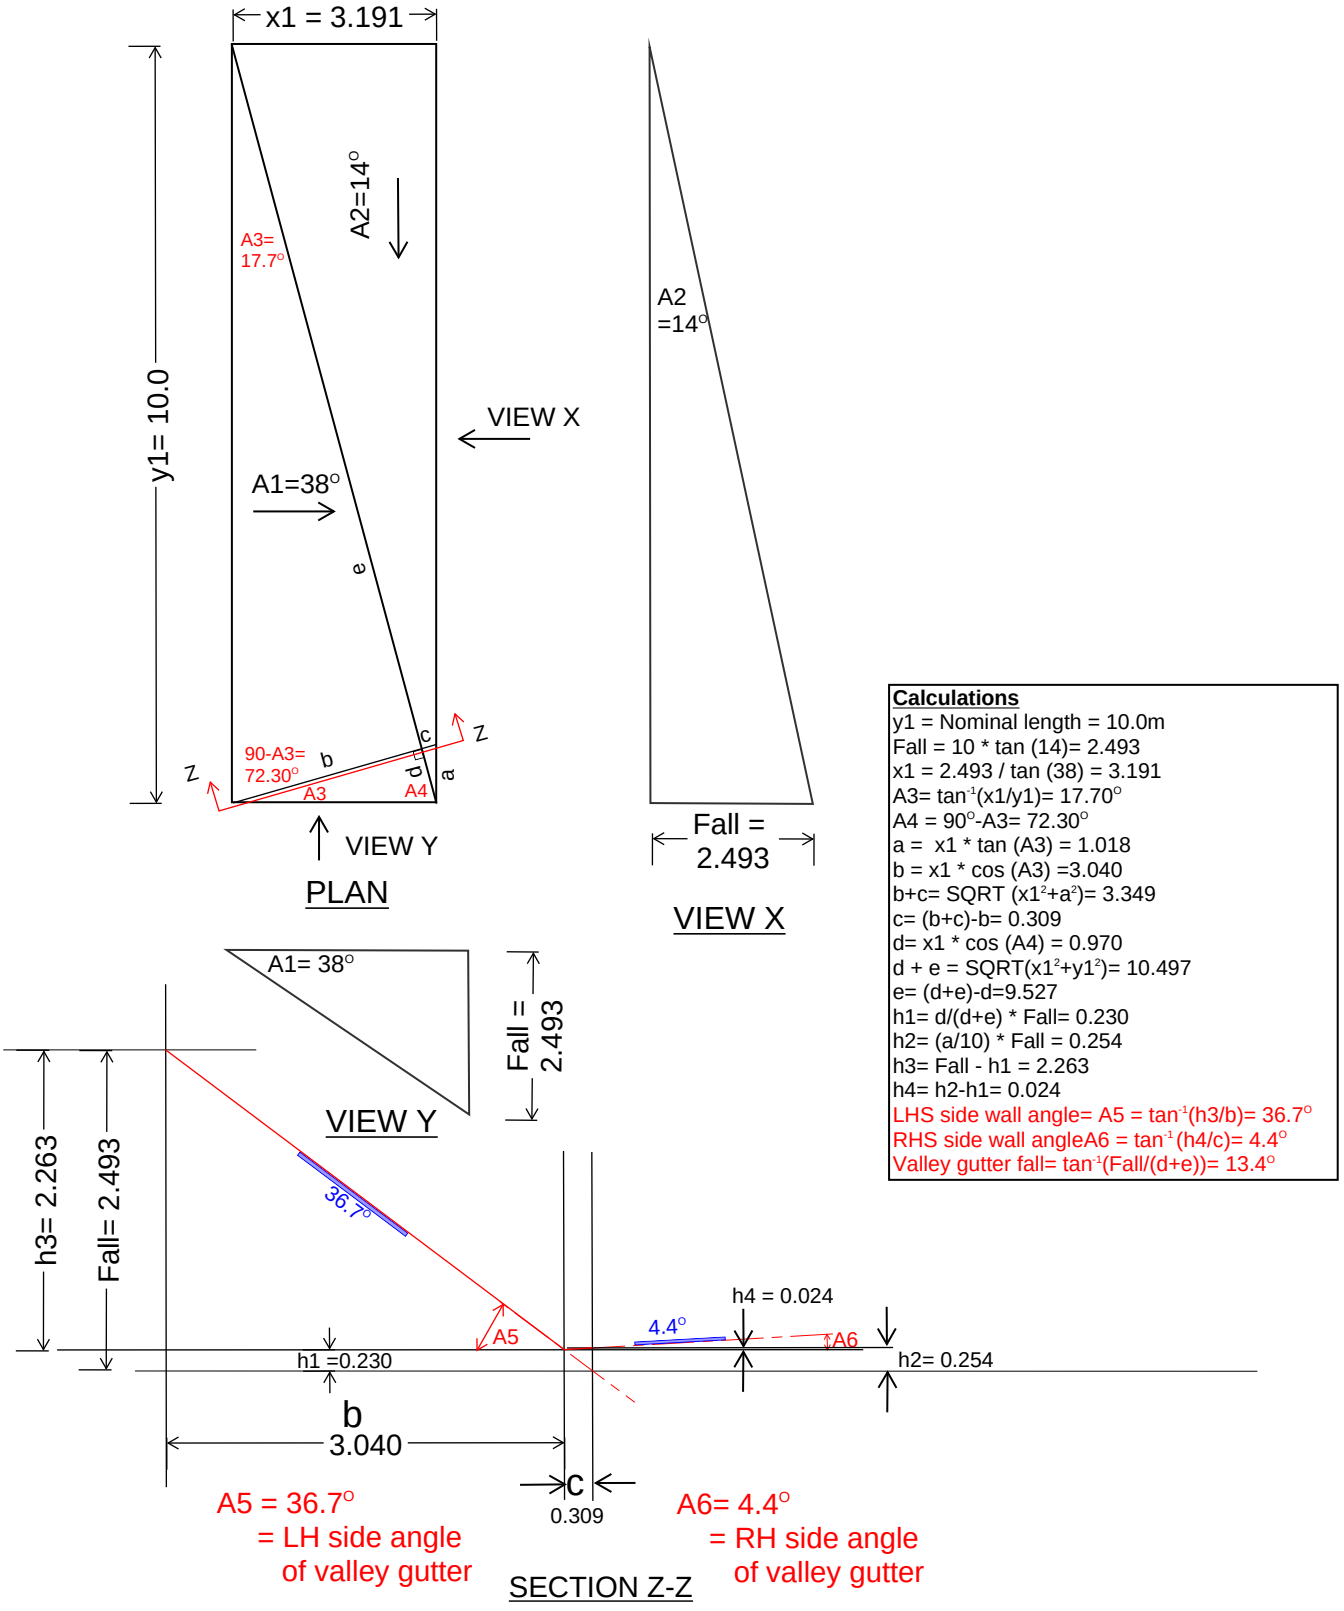
Beware when the slopes of intersecting roofs forming a valley gutter are not equal. In the example below, two roofs, having slopes of 38° and 14°, meet to form the line of the valley gutter. When viewing straight up / down the valley gutter, the side walls will have different slopes. However, the lower side wall slope can be much less than might be expected.

In the example below, although the lower roof slope of 14° is greater than the minimum roof slope of 12.5° permitted by AS/NZS 3500.3-2021 ('3500.3'), the lower side wall slope is only 4.4°, this being substantially less than the 'nominal' side angle of 16.5° specified in 3500.3, and certainly not enough to allow formation of an effective valley gutter.

y1 = Nominal length = 10.0m
Fall = 10 * tan (14)= 2.493
x1 = 2.493 / tan (38) = 3.191
A3= $\tan^{-1}$(x1/y1)= 17.70°
A4 = 90°-A3= 72.30°
a = x1 * tan (A3) = 1.018
b = x1 * cos (A3) =3.040
b+c= SQRT ($x1^2$+a^2)= 3.349
c= (b+c)-b= 0.309
d= x1 * cos (A4) = 0.970
d + e = SQRT($x1^2$+$y1^2$)= 10.497
e= (d+e)-d=9.527
h1= d/(d+e) * Fall= 0.230
h2= (a/10) * Fall = 0.254
h3= Fall - h1 = 2.263
h4= h2-h1= 0.024
LHS side wall angle= A5 = $\tan^{-1}$(h3/b)= 36.7°
RHS side wall angleA6 = $\tan^{-1}$(h4/c)= 4.4°
Valley gutter fall= $\tan^{-1}$(Fall/(d+e))= 13.4°

Note that for two roofs sloping at 22.5°, the side wall slopes are both 16.3°, this being similar to the nominal side wall slope noted above. However, for two roofs intersecting at 12.5°, the side wall slopes are 8.9°, which is significantly less than 16.5°. Hence allowing the roof slopes to be as low as 12.5° appears to be anomaly in the code. Furthermore, the code is silent on non-regular valley gutters, and the example below highlights the danger of valley gutters formed from intersecting roofs having different slopes. This needs to be addressed in 3500.3, as this is not uncommon in contemporary roof designs.
